# Did You Know...

**STINGRAY**  
Parts Washers

## Wash Pump System

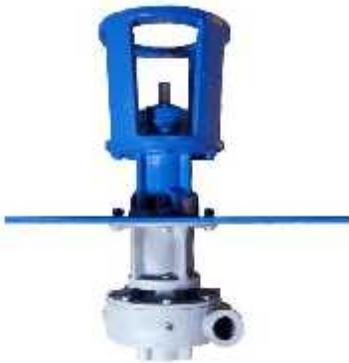
STINGRAY® Parts Washer users with wash pumps 20 H.P. or larger have a vertically mounted centrifugal pump specifically engineered for the STINGRAY Parts Washer application.

**Pump Description:** The pump system is a close-coupled centrifugal pump driven by a constant speed motor. The pump consists of a casing, shaft, and impeller, column, base-plate, bearing frame, and bearings. The bearing frame supports the bearings above the wash solution tank, thereby preventing contamination. A lip seal and air gap in the base plate further protect the bearings. The throttle bushing above the impeller casing “seals” the pump. The clearance between the shaft and the throttle bushing is very small. Hydrodynamic lubrication from the pumped solution flow through the throttle bushing prevents metal to metal contact. You might say that vertical centrifugal pumps are “sealed” by a controlled leak. STINGRAY’s newest pumps utilize a hardened stainless steel throttle bushing and shaft sleeve to reduce wear by a factor of 3 or 4 in this critical pump area.
